REPORT NO. 3546

THE ATCHISON, TOPEKA AND SANTA FE
RAILWAY COMPANY

AT MOORE, OKLA., ON

NOVEMBER 13, 1953

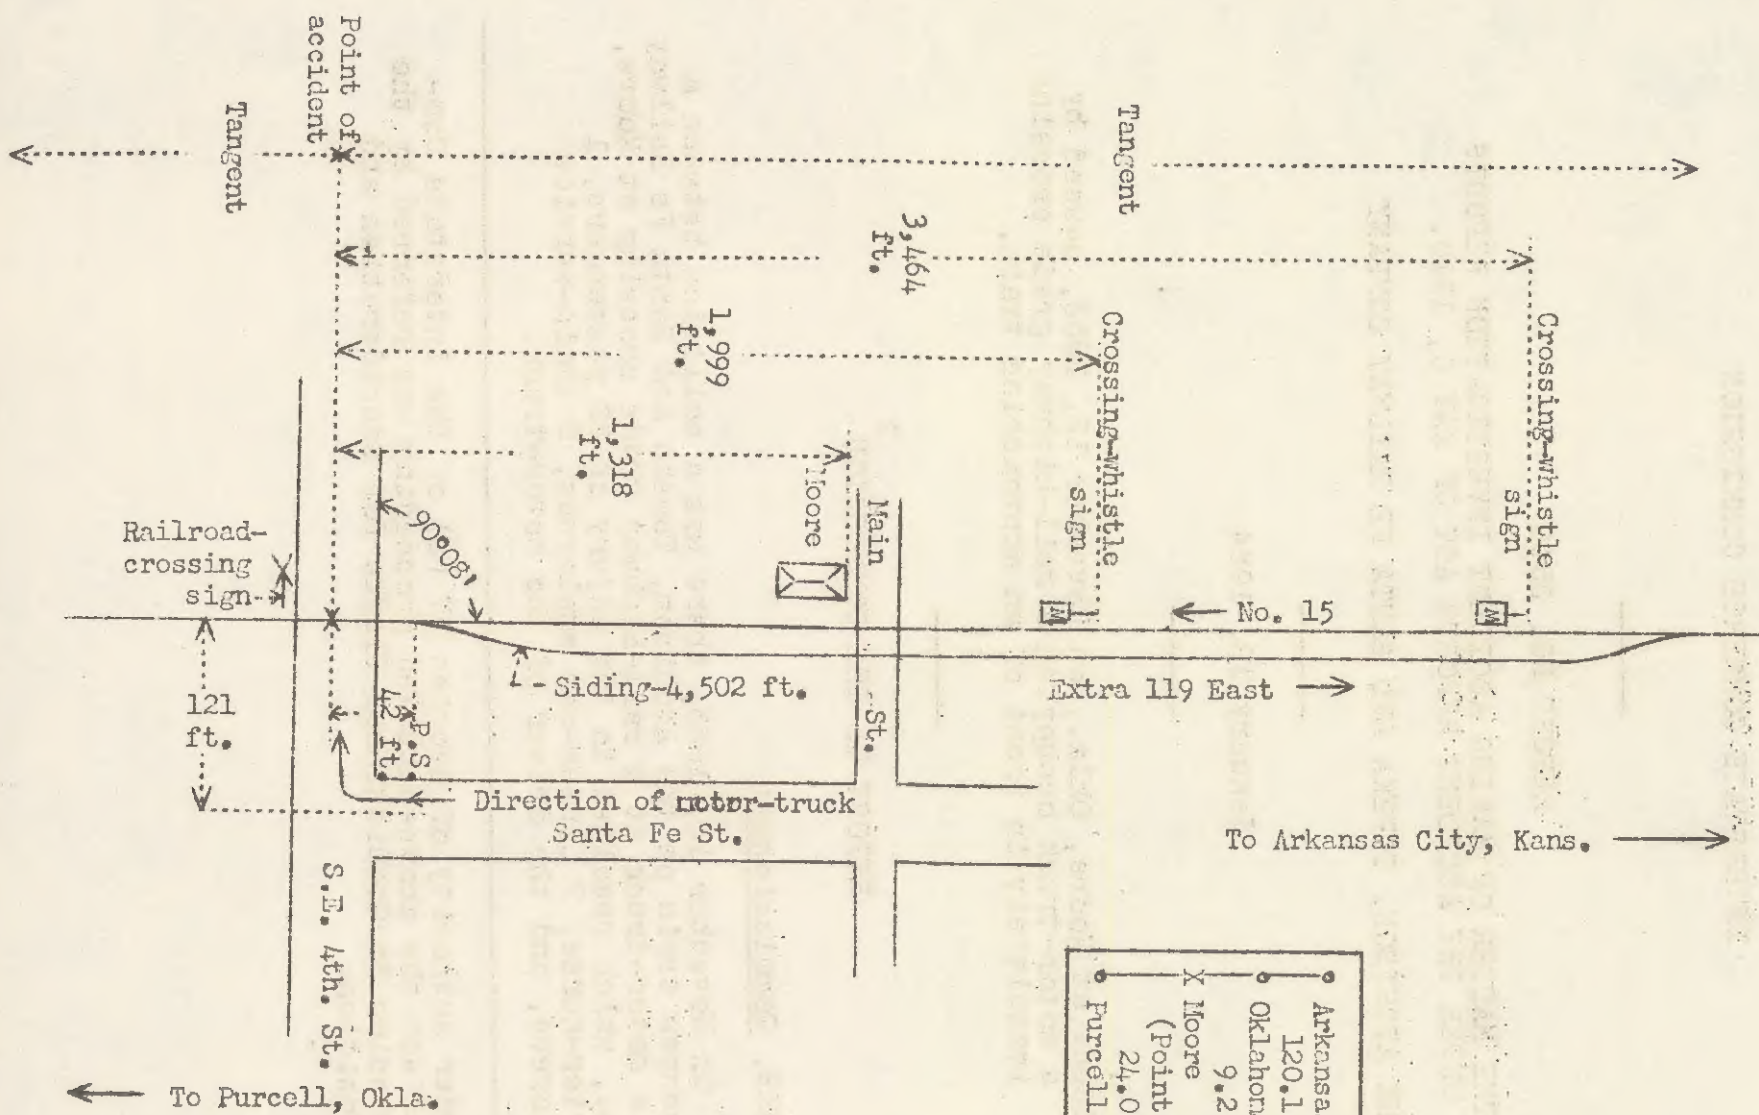
This accident occurred on that part of the Oklahoma Division extending between Arkansas City, Kans., and Purcell, Okla., 153.3 miles. In the vicinity of the point of accident this is a single-track line, over which trains are operated by timetable, train orders, and an automatic block-signal system. The accident occurred on the main track at a point 129.5 miles west of Arkansas City and 1,318 feet west of the station at Moore, Okla., where the railroad is crossed at grade by S.E. 4th Street. The track at this point extends practically north and south, and the highway practically east and west. Timetable directions on the railroad are east and west, and these directions are used in this report. The railroad is tangent throughout a distance of more than 1 mile immediately east of the point of accident and a considerable distance westward. The grade for west-bound trains is 0.44 percent descending at the point of accident. At Moore a siding 4,502 feet long parallels the main track on the south. The west switch of this siding is 42 feet east of the point of accident. S.E. 4th Street is tangent throughout a considerable distance on each side of the crossing and intersects the railroad at an angle of $90^{\circ}08'$. The crossing is 24 feet in width and is surfaced with planking to the level of the tops of the rails. The street is surfaced with sand and is 24 feet in width. South of the crossing Santa Fe Street extends eastward from S.E. 4th Street and parallels the railroad at a distance of 121 feet. The grade for north-bound vehicles on S.E. 4th Street between Santa Fe Street and the main track of the railroad is, successively, 5.2 percent ascending 61 feet, 3.1 percent ascending 32 feet, and 1.4 percent ascending 28 feet to the crossing.

A standard cross-buck railroad-crossing sign is located to the left of the direction of north-bound traffic on S.E. 4th Street, approximately 21 feet west of the center-line of the street and 16 feet 4 inches north of the center-line of the main track. This sign is mounted on a mast 10 feet above the level of the street and bears the words "RAILROAD CROSSING" in black on a white background. The mast bears the words "LOOK OUT FOR THE CARS" in black on a white background. A crossing-whistle sign for west-bound trains is located 1,999 feet east of the crossing.
